CONSERVATION NEEDS ASSESSMENT REPORT FOR  
**THE PARTHENON AND HISTORIC CONCRETE STRUCTURES AT CENTENNIAL PARK**

PREPARED FOR:  
METROPOLITAN HISTORICAL COMMISSION OF NASHVILLE  
AND  
CENTENNIAL PARK CONSERVANCY

BY  
CULTURAL HERITAGE CONSERVATION LLC  
&  
SILMAN

30 SEPTEMBER 2021

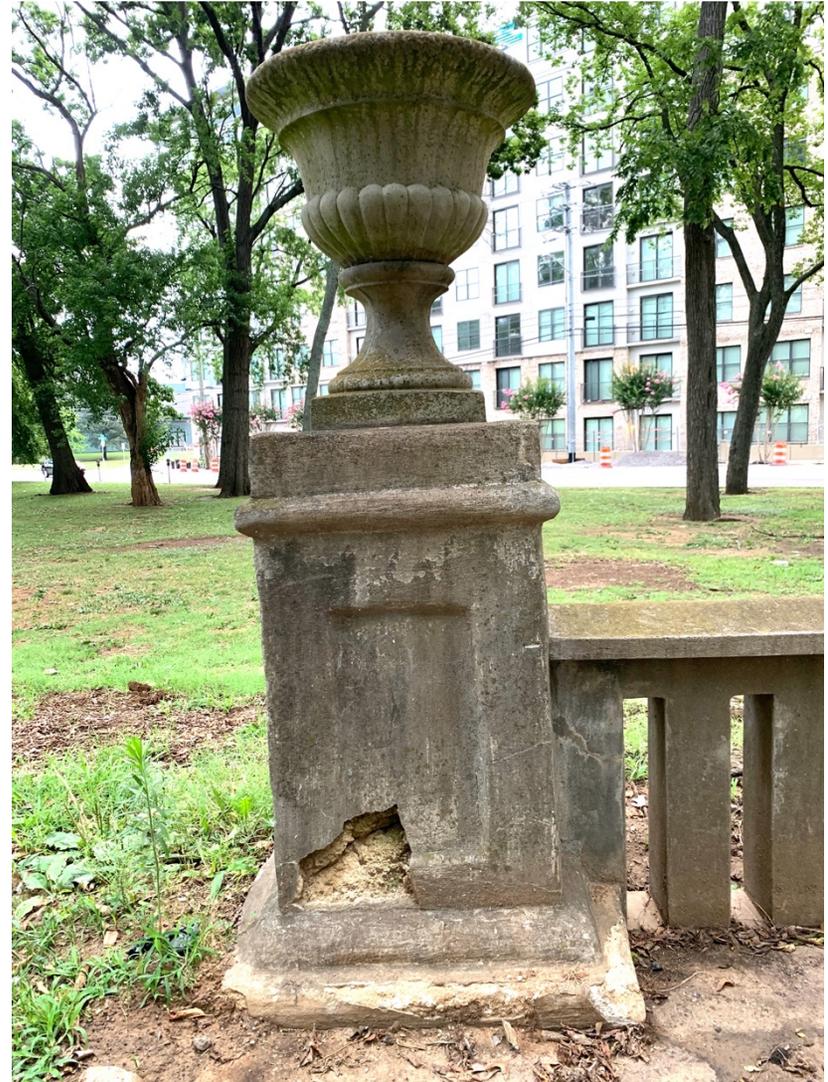
Figure 116: The north post of the east railing is in the worst surface condition of all the posts with the most parge loss, concrete cracks, and disaggregation.
